111 Jefferson

## Table of Contents

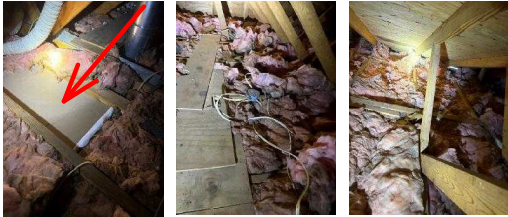
1. Accessible portions. Attic Insulation Depth: 8" estimated. Missing insulation in one area. \*This amount of insulation may have been adequate when this house was built but isn't adequate by today's standards. More insulation is recommended.

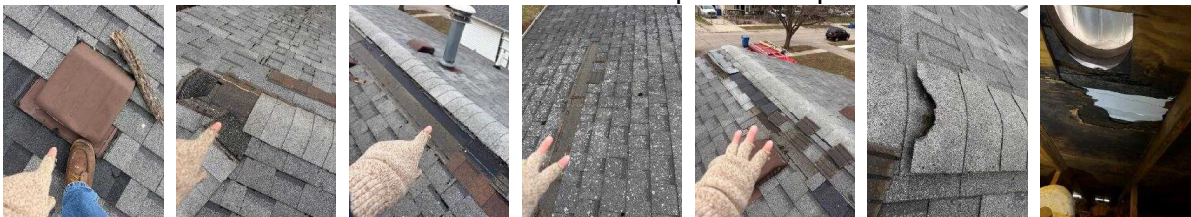
23. All. Roof Surface Condition: Asphalt shingles. Shingles missing in four different areas. Damaged sheathing (plywood) seen from the attic. It looks like a raccoon was getting in the attic through a hole in the roof. Feces seen in the attic.

There was a previous patch done to the roof. I think this is where the raccoon was getting into the attic. The sheathing was patched with a piece of aluminum under the shingles in order to cover the hole. The bad plywood (sheathing) should have been cut out and replaced. The roof is soft in this area of the improper patch. The last picture is the patched area visible from the attic. A professional roofer may recommend the roof be replaced. A qualified roofing contractor is recommended to evaluate and estimate repairs/replacement.

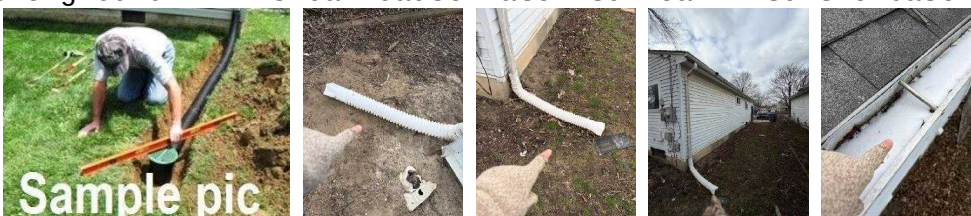
24. All. Roof Surface Gutters & Downspouts & Extensions: Metal. Extend downspouts so that they deposit water at least 10 feet from house (where possible). Water too close to the foundation will cause basement and/or crawl spaces to leak or flood and any sump pumps to work harder. Signs of previous leaking seen in the basement.

Gutters full of leaves, won't drain and water will pour over the sides and onto the ground. This can cause water to leak into the basement.
